A Comparison of the Efficacy of Gutter Pan and Curb Top Placement with a Full Gateway Configuration of the In-Street Sign on Driver Yielding to Pedestrians

A thesis submitted to the Graduate College
in partial fulfillment of the requirements
for the degree of Master of Arts
Psychology
Western Michigan University
December 2019

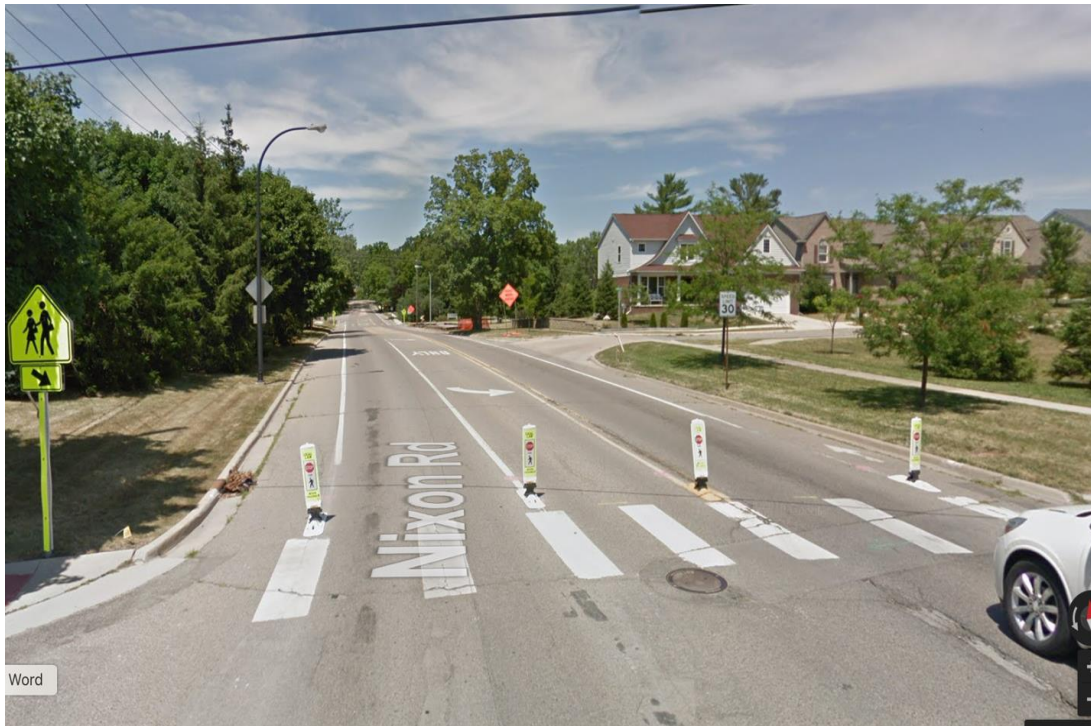
Figure 1. Nixon Road Site

Three sites were assessed in Ann Arbor, Michigan. Two of the locations in the study featured an unsignalized pedestrian crosswalk. One site featured a pedestrian activated Rectangular Rapid Flashing Beacon (RRFB) (Shurbutt, Van Houten, Turner, and Huitema, 2009), but the activation button was not used during the experiment. If a natural pedestrian chose to activate the beacon, the motorists' behavior was not measured. Lane measurements at each site were also recorded. The first site was a crosswalk located at the North leg of Nixon at the intersection with Bluett. Nixon road had three motor vehicle travel lanes and allowed for northbound and southbound travel. One of the lanes was a left turning lane. This lane was on the southbound side. Both the northbound and southbound lanes included a designated bicycle lane. The southbound lane measured 17.5 ft. wide including the bicycle lane. The left turn lane, which was also southbound, measured 16.66 ft. wide. The northbound lane at this site had a width of 14 ft. The posted speed limit on this road was 30 mph. The flow of traffic appeared to frequently

exceed the posted limit during observations. There was a posted speed limit sign in close proximity to the site. At each end of sidewalk before the start of the bicycle lanes there was a yellow pedestrian crossing sign signifying a crosswalk. R1-6 Signs were located on the centerline, on the lane line and on both bicycle lanes.

Two different configurations of the gateway were assessed at each location (on curb top and in gutter pan), and compared to baseline levels of yielding. At Nixon Road, the curb top configuration consisted of an R1-6a sign placed on the left side, on top of the curb adjacent to the pedestrian island, and a second R1-6a sign was placed on the right side on top of the curb. The gutter pan gateway configuration involved an R1-6a sign placed on the left side, in the gutter pan adjacent to the pedestrian island, and a second R1-6a sign was placed on the right side, in the gutter pan. A R1-6a sign was placed on the centerline and left turn lane for both configurations.

The percentage of driver yielding right of way to pedestrians in the crosswalk under each condition at the Nixon Road were assessed. Baseline yielding at this location averaged 39.6%, while the curb top configuration of the R1-6 sign increased average yielding to 86.4%. However, the gutter pan configuration produced average yielding of 93.2%. A center lane only probe was conducted which resulted in a yielding percentage of 68.3%.

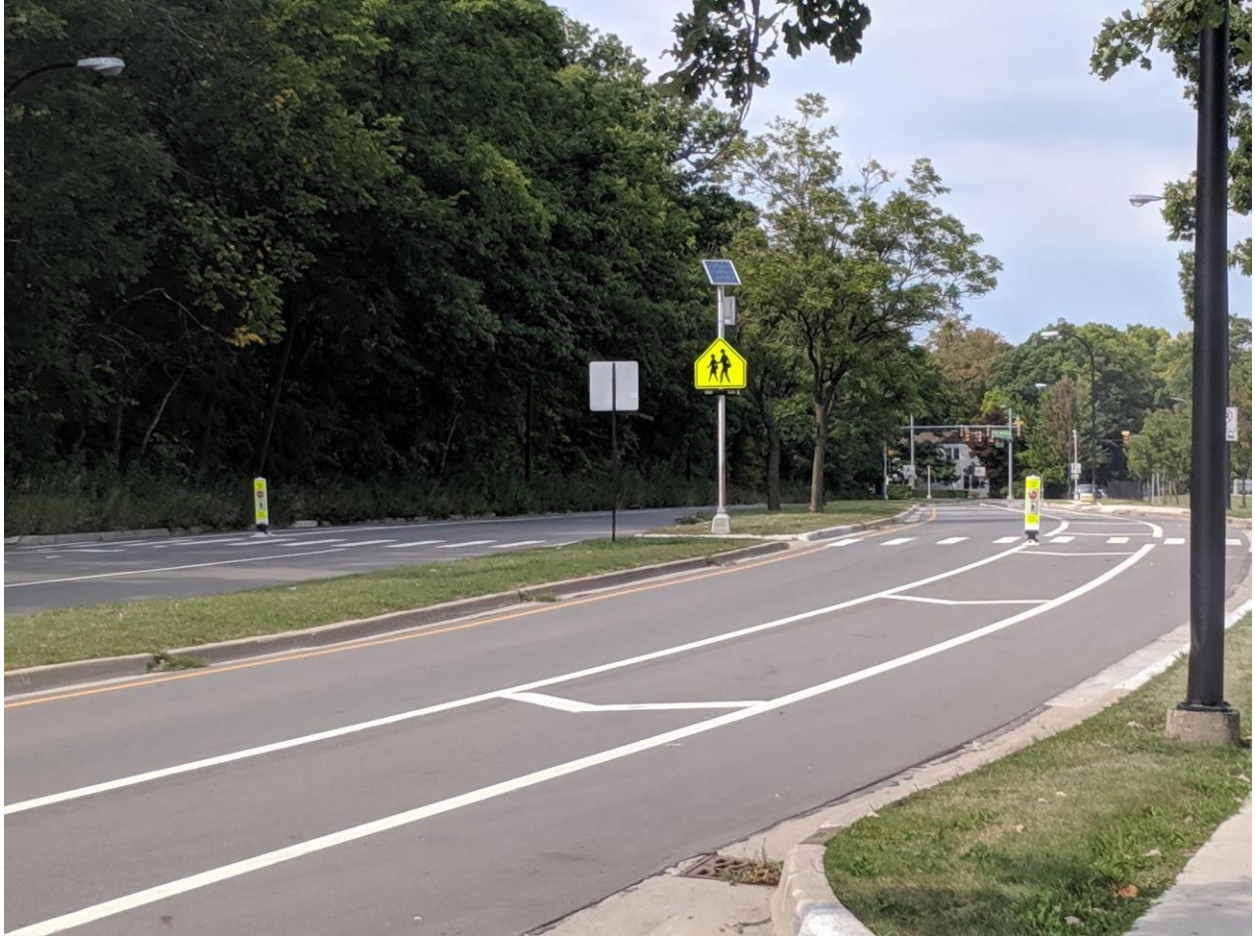
Figure 2. Nixon Road Site

The second site was a crosswalk on North 7th Street, adjacent to Pioneer High School. The speed limit at this site was 35 mph. Observation periods were conducted when school was not in session. On the southbound side of the crosswalk was an entrance to a wooded trail. This site has a large volume of pedestrian and motor vehicle traffic. The crosswalk included a median that separated the two directions of travel. This site was comprised of one travel lane and a bike lane going north and one travel lane, a turn lane, as well as a bike lane going south. One of the

lanes was a left turning lane. This lane was on the southbound side. There was also a buffer area between the motorist lanes and bicycle lanes. The southbound lane measured 20.75 ft. wide including the bicycle lane. The southbound left turn lane measured 12.25 ft. wide. The midblock median separating the direction of travel measured 9.5 ft. wide. The northbound lane measured 18.25 ft. wide. The buffer area between the motorist lane and bicycle lane measured 3.5 ft. on both the southbound and northbound lanes. At each end of sidewalk before the start of the bicycle lanes on the grass near the curb there was a yellow pedestrian crossing sign signifying a crosswalk. There was also the same sign in the midblock. This site featured a RRFB which could be activated by pressing the button on the pedestrian crossing sign pole. Since the other two sites did not have a RRFB, beacon was not used during the experiment.

At 7th Street, the curb top configuration consisted of an R1-6a sign placed on the left side, on top of the curb adjacent to the pedestrian island, and a second R1-6a was placed on the right side of on top of the curb. A R1-6a sign was also placed on top of the curb on the median island. The gutter pan configuration involved an R1-6a sign placed on the left side, in the gutter pan adjacent to the median island, and a second R1-6a sign was placed on the right side, in the gutter pan. A R1-6a sign was placed in the gutter pan on the right and left side of the median. A R1-6a sign was placed on the centerline and left turning lane for both configurations.

The percentage of driver yielding right of way to pedestrians in the crosswalk under each condition at the 7th Street site were assessed. Baseline yielding at this location averaged 15.2%, while the curb top configuration of the R1-6a sign increased yielding to 59.1%. However, the gutter pan configuration produced a higher average yielding of 69.9%.

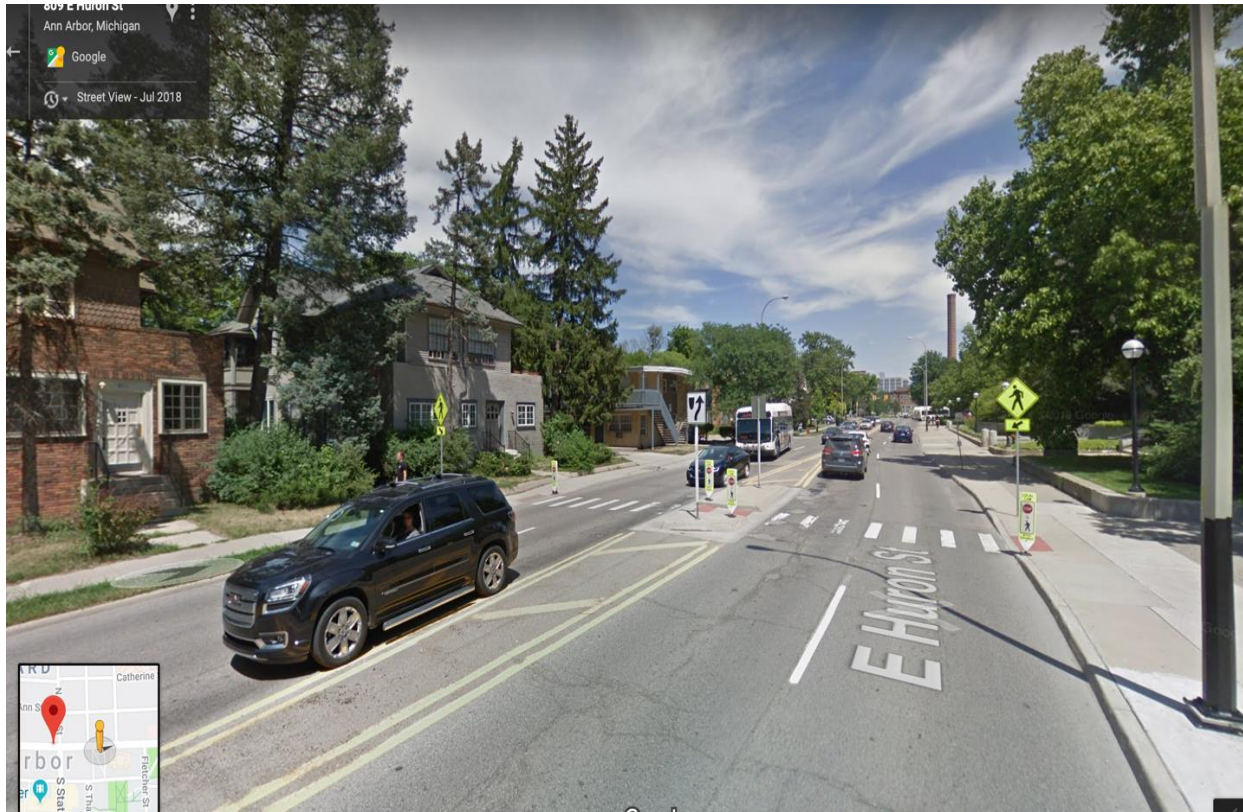
Figure 3. Huron Street Site

The third site was Huron Street. This was a busy location with a lot of motorist and pedestrian traffic. The speed limit at this location was 35 mph. This site was located next to a University of Michigan dormitory and two blocks away from the main campus. Huron Street had two-way traffic with two lanes in each direction and pedestrian refuge island separating the direction of travel. Huron road carried traffic traveling in an eastbound and westbound direction. There were no bicycle lanes on this street. There were yellow pedestrian crossing signs on both ends of the crosswalk near the sidewalk. The midblock contained a keep right sign, but did not

have any pedestrian crossing signage. The eastbound lane was 21.83 ft. wide. The westbound lane was 21.75 ft wide.

At Huron Street, the curb top configuration consisted of an R1-6a sign placed on the left side, on top of the curb on each side of the pedestrian island, and an R1-6a was placed on the top the lane line on each side of the road. A R1-6a sign was also placed on the curb on the right side of the road in each direction. The gutter pan configuration involved an R1-6a sign placed on the left side, in the gutter pan adjacent to the pedestrian island, and a second R1-6a sign was placed on the right side, in the gutter pan in each direction. A R1-6a sign was placed on the centerline for both directions of travel. In each case, the particulars of these sign configurations were

The percentage of driver yielding right of way to pedestrians in the crosswalk under each condition at Huron Street were assessed. Baseline yielding at this location averaged 61.8%. The curb top configuration of the R1-6a sign increased yielding to 92.0%. The gutter pan configuration of the R1-6a sign at this site produced an average yielding of 97.6%. At this location, both the curb top and gutter pan configurations produced comparable high levels of yielding.

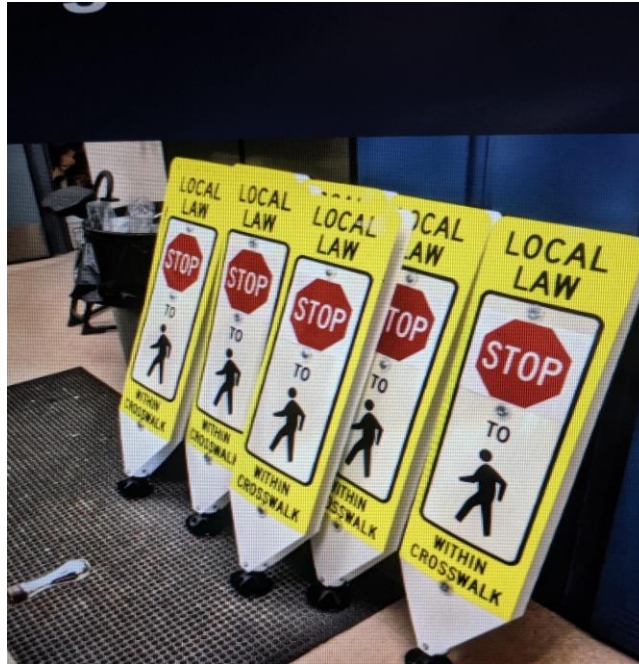
Figure 4. R1-6a sign with portable base.

This study used an in-street pedestrian crossing sign called a R1-6a sign. This sign contained a written command that clearly was designed to serve as a prompt for motorists to come to a complete stop when pedestrians are present in or near the crosswalk. The sign consisted of a fluorescent yellow-green reflective sheeting. In the middle of the sign there was a white background with a red stop sign, with the words "for" below that, and a black pedestrian symbol below that. It was also clearly stated on the sign that this is local law. Each sign was attached to a portable rubber base. They were not bolted or attached to the surface of the road,

the position of the sign could be changed during different conditions of the experiment. During the study we would place the signs in various configurations and collect data. Being able to relocate and reconfigure the signs was needed to conduct the study.
