A Comparison of the Efficacy of Gutter Pan and Curb Top Placement with a Full Gateway Configuration of the In-Street Sign on Driver Yielding to Pedestrians

A thesis submitted to the Graduate College
in partial fulfillment of the requirements
for the degree of Master of Arts
Psychology
Western Michigan University
December 2019

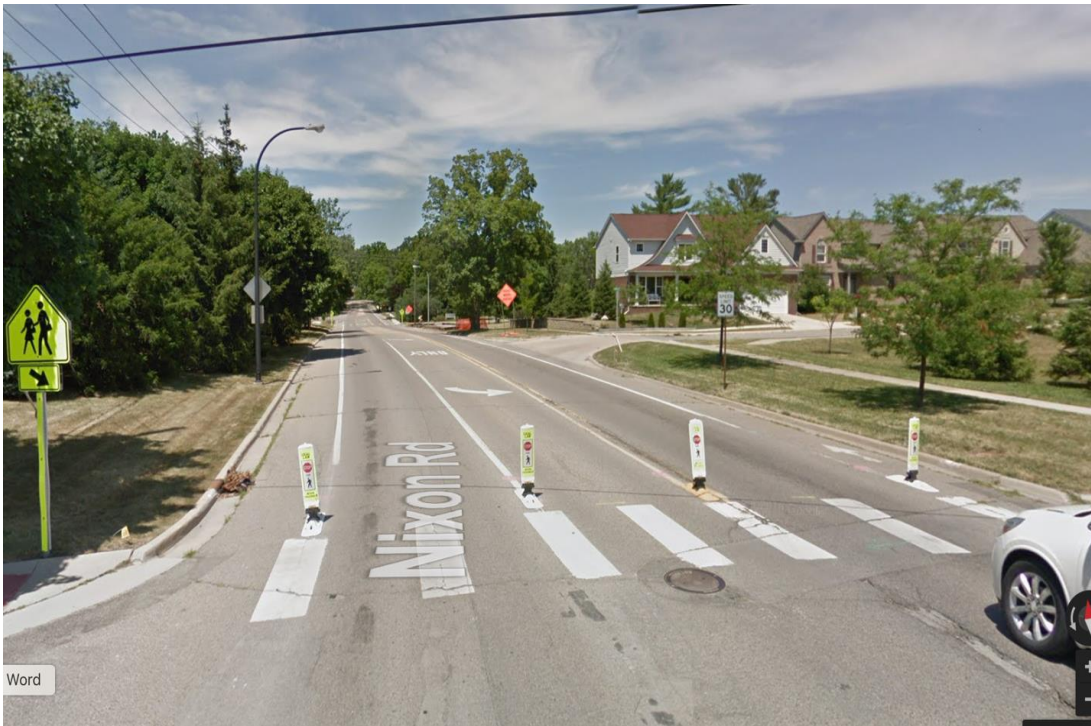
Figure 1. Nixon Road Site

Three sites were assessed in Ann Arbor, Michigan. Two of the locations in the study featured an unsignalized pedestrian crosswalk. One site featured a pedestrian activated Rectangular Rapid Flashing Beacon (RRFB) (Shurbutt, Van Houten, Turner, and Huitema, 2009), but the activation button was not used during the experiment. If a natural pedestrian chose to activate the beacon, the motorists' behavior was not measured. Lane measurements at each site were also recorded. The first site was a crosswalk located at the North leg of Nixon at the intersection with Bluett. Nixon road had three motor vehicle travel lanes and allowed for northbound and southbound travel. One of the lanes was a left turning lane. This lane was on the southbound side. Both the northbound and southbound lanes included a designated bicycle lane. The southbound lane measured 17.5 ft. wide including the bicycle lane. The left turn lane, which was also southbound, measured 16.66 ft. wide. The northbound lane at this site had a width of 14 ft. The posted speed limit on this road was 30 mph. The flow of traffic appeared to frequently

exceed the posted limit during observations. There was a posted speed limit sign in close proximity to the site. At each end of sidewalk before the start of the bicycle lanes there was a yellow pedestrian crossing sign signifying a crosswalk. R1-6 Signs were located on the centerline, on the lane line and on both bicycle lanes.

Two different configurations of the gateway were assessed at each location (on curb top and in gutter pan), and compared to baseline levels of yielding. At Nixon Road, the curb top configuration consisted of an R1-6a sign placed on the left side, on top of the curb adjacent to the pedestrian island, and a second R1-6a sign was placed on the right side on top of the curb. The gutter pan gateway configuration involved an R1-6a sign placed on the left side, in the gutter pan adjacent to the pedestrian island, and a second R1-6a sign was placed on the right side, in the gutter pan. A R1-6a sign was placed on the centerline and left turn lane for both configurations.

The percentage of driver yielding right of way to pedestrians in the crosswalk under each condition at the Nixon Road were assessed. Baseline yielding at this location averaged 39.6%, while the curb top configuration of the R1-6 sign increased average yielding to 86.4%. However, the gutter pan configuration produced average yielding of 93.2%. A center lane only probe was conducted which resulted in a yielding percentage of 68.3%.

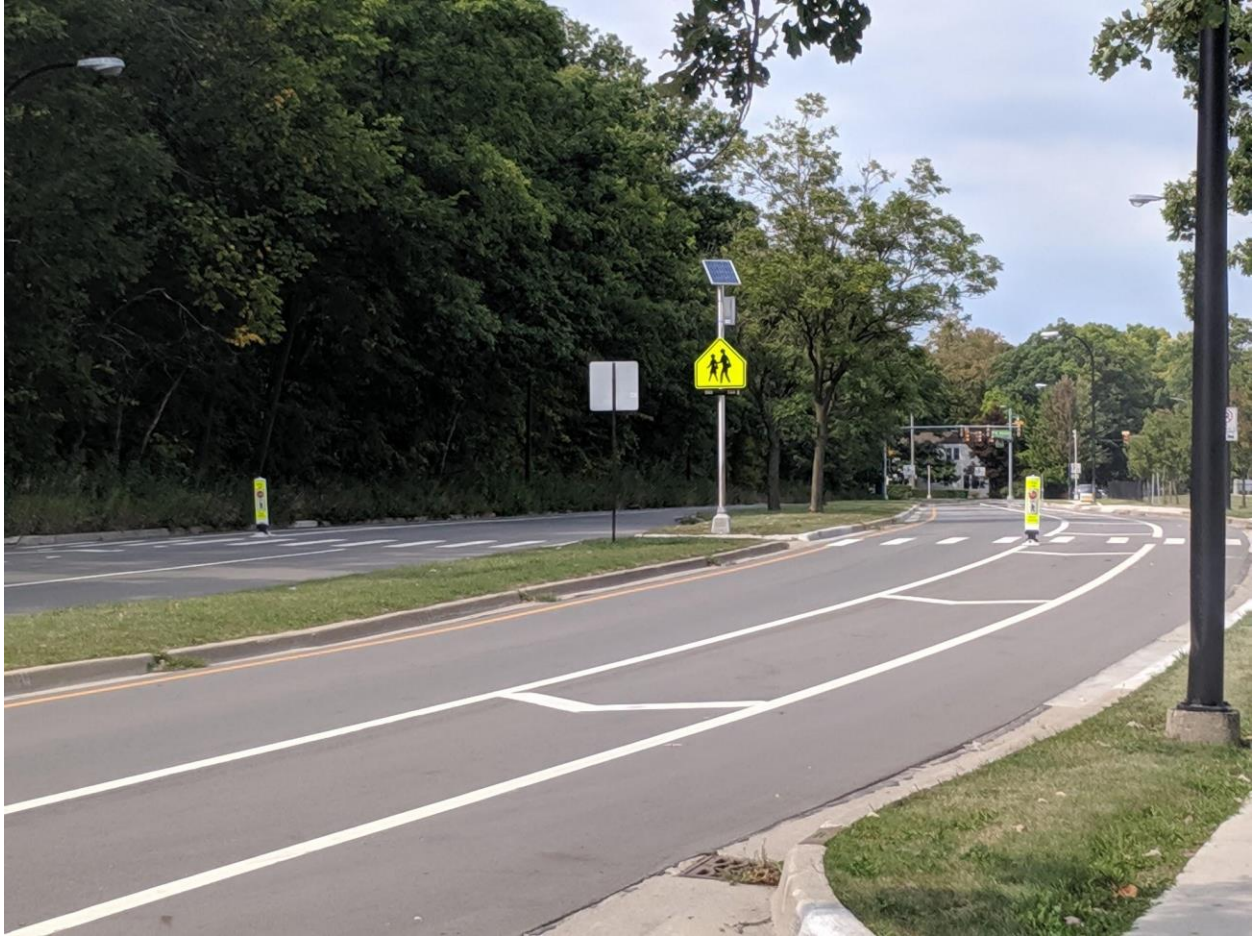
Figure 2. Nixon Road Site

The second site was a crosswalk on North 7th Street, adjacent to Pioneer High School. The speed limit at this site was 35 mph. Observation periods were conducted when school was not in session. On the southbound side of the crosswalk was an entrance to a wooded trail. This site has a large volume of pedestrian and motor vehicle traffic. The crosswalk included a median that separated the two directions of travel. This site was comprised of one travel lane and a bike lane going north and one travel lane, a turn lane, as well as a bike lane going south. One of the

lanes was a left turning lane. This lane was on the southbound side. There was also a buffer area between the motorist lanes and bicycle lanes. The southbound lane measured 20.75 ft. wide including the bicycle lane. The southbound left turn lane measured 12.25 ft. wide. The midblock median separating the direction of travel measured 9.5 ft. wide. The northbound lane measured 18.25 ft. wide. The buffer area between the motorist lane and bicycle lane measured 3.5 ft. on both the southbound and northbound lanes. At each end of sidewalk before the start of the bicycle lanes on the grass near the curb there was a yellow pedestrian crossing sign signifying a crosswalk. There was also the same sign in the midblock. This site featured a RRFB which could be activated by pressing the button on the pedestrian crossing sign pole. Since the other two sites did not have a RRFB, beacon was not used during the experiment.

At 7th Street, the curb top configuration consisted of an R1-6a sign placed on the left side, on top of the curb adjacent to the pedestrian island, and a second R1-6a was placed on the right side of on top or the curb. A R1-6a sign was also placed on top of the curb on the median island. The gutter pan configuration involved an R1-6a sign placed on the left side, in the gutter pan adjacent to the median island, and a second R1-6a sign was placed on the right side, in the gutter pan. A R1-6a sign was placed in the gutter pan on the right and left side of the median. A R1-6a sign was placed on the centerline and left turning lane for both configurations.

The percentage of driver yielding right of way to pedestrians in the crosswalk under each condition at the 7th Street site were assessed. Baseline yielding at this location averaged 15.2%, while the curb top configuration of the R1-6a sign increased yielding to 59.1%. However, the gutter pan configuration produced a higher average yielding of 69.9%.

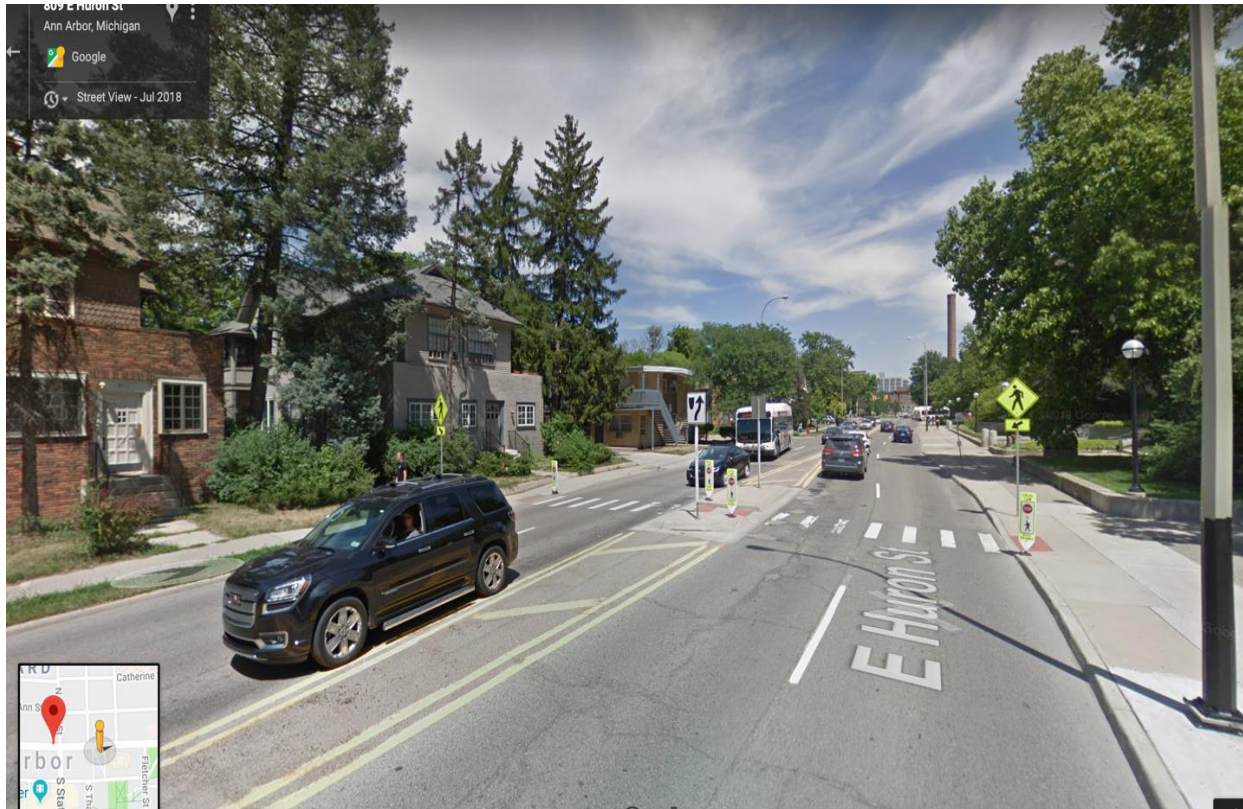
Figure 3. Huron Street Site

The third site was Huron Street. This was a busy location with a lot of motorist and pedestrian traffic. The speed limit at this location was 35 mph. This site was located next to a University of Michigan dormitory and two blocks away from the main campus. Huron Street had two-way traffic with two lanes in each direction and pedestrian refuge island separating the direction of travel. Huron road carried traffic traveling in an eastbound and westbound direction. There were no bicycle lanes on this street. There were yellow pedestrian crossing signs on both ends of the crosswalk near the sidewalk. The midblock contained a keep right sign, but did not

have any pedestrian crossing signage. The eastbound lane was 21.83 ft. wide. The westbound lane was 21.75 ft wide.

At Huron Street, the curb top configuration consisted of an R1-6a sign placed on the left side, on top of the curb on each side of the pedestrian island, and an R1-6a was placed on the top the lane line on each side of the road. A R1-6a sign was also placed on the curb on the right side of the road in each direction. The gutter pan configuration involved an R1-6a sign placed on the left side, in the gutter pan adjacent to the pedestrian island, and a second R1-6a sign was placed on the right side, in the gutter pan in each direction. A R1-6a sign was placed on the centerline for both directions of travel. In each case, the particulars of these sign configurations were

The percentage of driver yielding right of way to pedestrians in the crosswalk under each condition at Huron Street were assessed. Baseline yielding at this location averaged 61.8%. The curb top configuration of the R1-6a sign increased yielding to 92.0%. The gutter pan configuration of the R1-6a sign at this site produced an average yielding of 97.6%. At this location, both the curb top and gutter pan configurations produced comparable high levels of yielding.

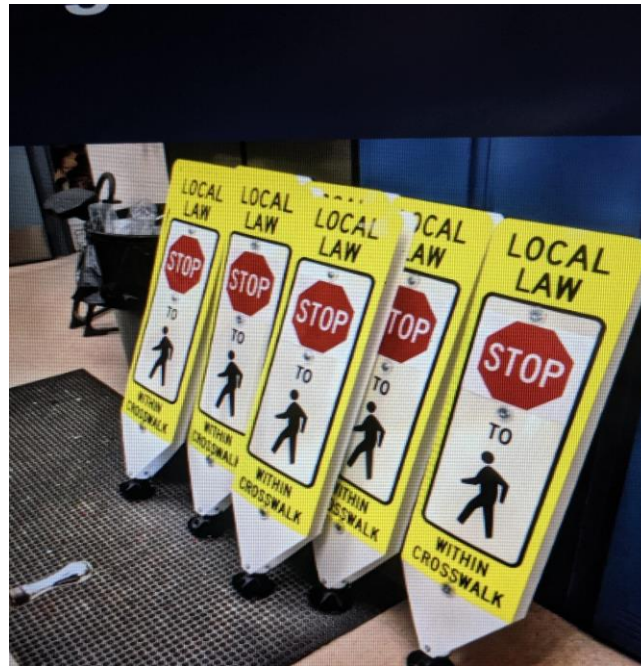
Figure 4. R1-6a sign with portable base.

This study used an in-street pedestrian crossing sign called a R1-6a sign. This sign contained a written command that clearly was designed to serve as a prompt for motorists to come to a complete stop when pedestrians are present in or near the crosswalk. The sign consisted of a fluorescent yellow-green reflective sheeting. In the middle of the sign there was a white background with a red stop sign, with the words "for" below that, and a black pedestrian symbol below that. It was also clearly stated on the sign that this is local law. Each sign was attached to a portable rubber base. They were not bolted or attached to the surface of the road,

the position of the sign could be changed during different conditions of the experiment. During the study we would place the signs in various configurations and collect data. Being able to relocate and reconfigure the signs was needed to conduct the study.
